**NATIONAL OCEANIC AND ATMOSPHERIC  
ADMINISTRATION  
OFFICE OF THE CHIEF ADMINISTRATIVE OFFICER  
WESTERN REGIONAL CENTER**

**18' SEA-ARK BOAT SINKING INCIDENT**

**OCTOBER 31, 2012**

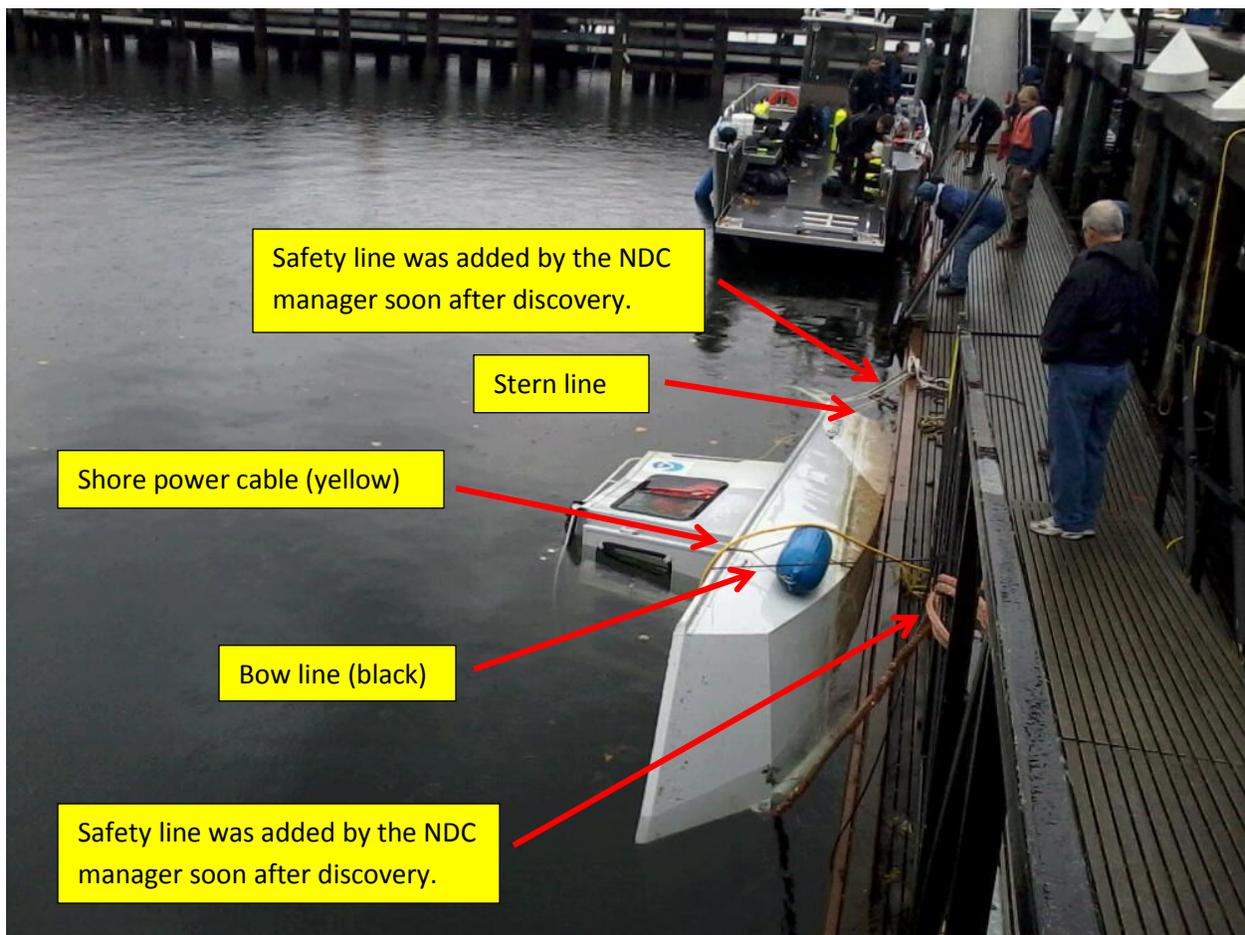
On October 31, 2012, at approximately 0800, members of the NOAA Dive Center were on board the M/V Dinsmore preparing for dive operations on the NOAA Ship Miller Freeman. The M/V Dinsmore was tied up to the finger pier inside the boat basin. A member of the dive crew observed the 18ft. Sea Ark listing heavily to starboard and had a pitch angle of about 15° - 20° degrees down by the stern. The Southern half of the floating pier was rolled at about a 5° - 10° degree angle due to the weight of the sinking vessel being suspended by the pier's west face. The vessel was secured by a bow and stern line (the orange line located underneath the bow was placed by the dive crew as a means of keeping the vessel from completely sinking) and the shore power cable was still connected (the electrical power to the cable was immediately disconnected at the pier side by the NDC Manager).

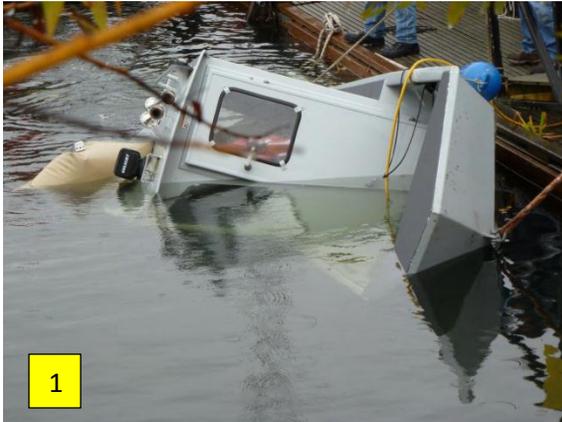
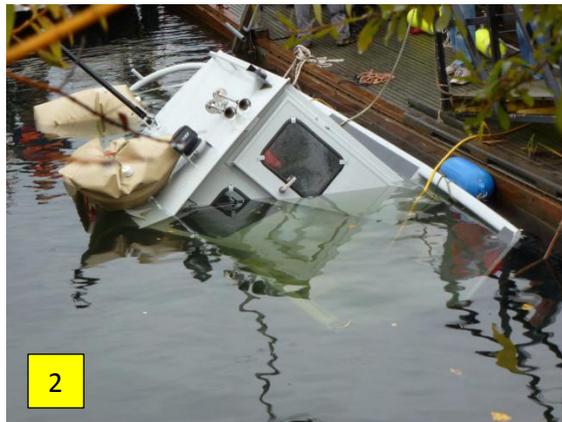
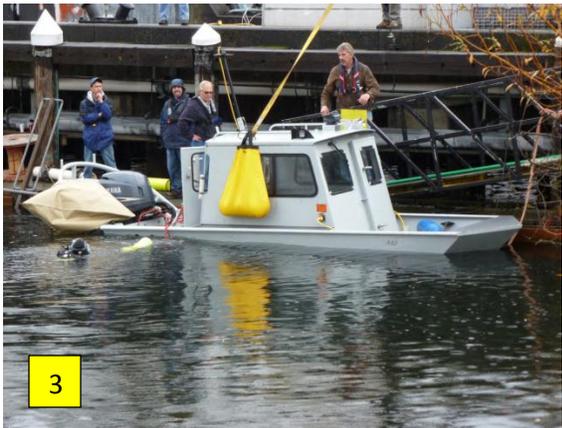
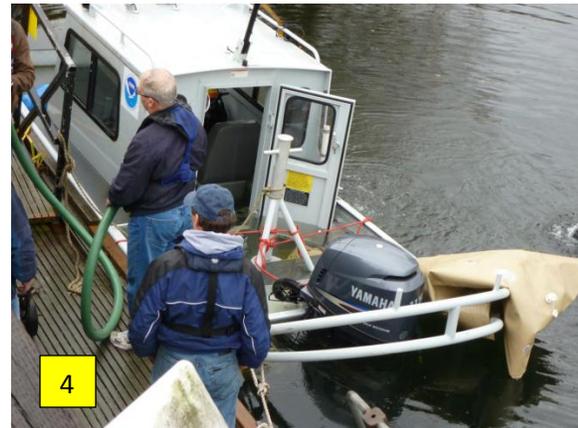
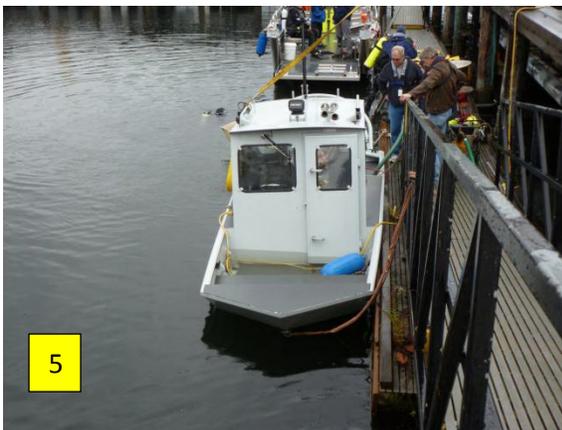
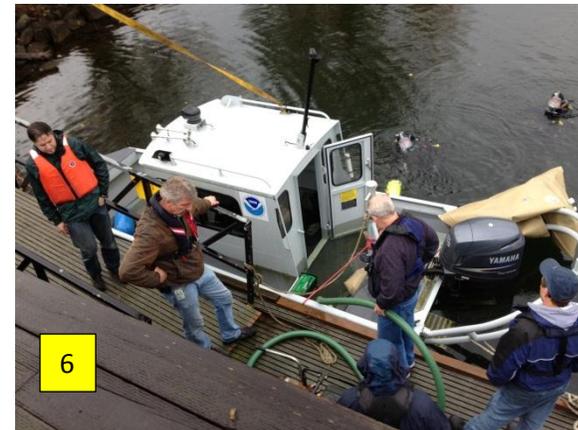
The NOAA Dive Center splashed two divers in the water to commence the recovery of the Sea Ark. After the initial visual assessment and report by the in-water divers, the dive supervisor instructed the dive team to lift the vessel using lift bags and securing additional lines to prevent the vessel from sinking. As the vessel surfaced upright a water pump was used to remove water from inside the deck area and wheel house.

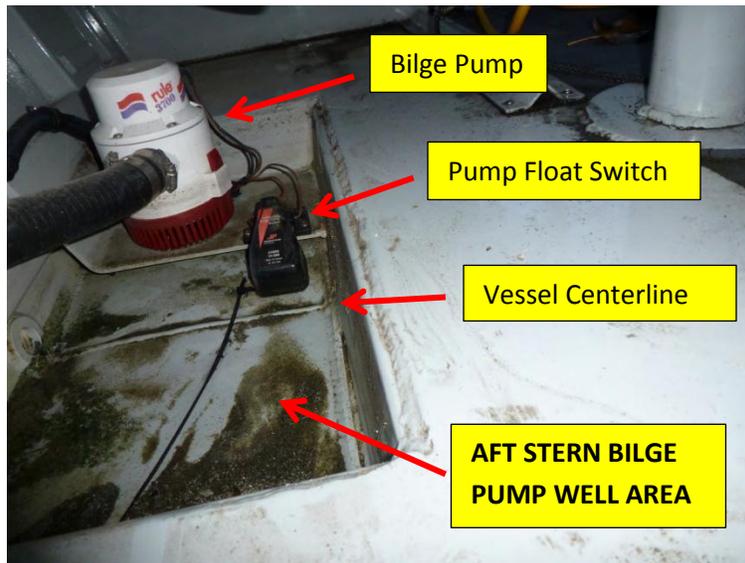
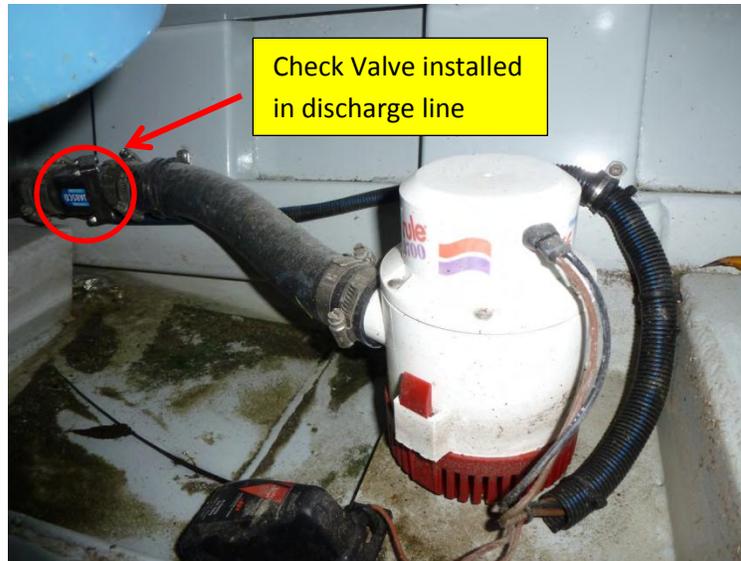
Water Intrusion in the Bilge. This vessel has an as-built STBD list. The vessel is designed to have any water coming into the boat flow from the bow to the stern via the bilge. Drain holes located inside the bilge area were obstructed with debris causing the water to build up, compromising stability and buoyancy and, lowering the level of the boat in the water. It was observed that there is not a continuous weld along the seams of deck surfaces, adding to the potential intrusion of water into the hull area. The bilge pump float switch was located at portside center inside the pump well. During vessel recovery, it was observed that the pump switch was set in the “automatic” position and as such should have engaged once the float had risen to the activation point. With water trapped in the bilge, the vessel began to list to the STBD side rendering the bilge pump float switch useless since the water line was at the opposite side of the boat from the float switch. With the added effects of rain and wind, the vessel began to list to STBD. With the vessel listing to STBD, the center of gravity of the vessel shifted causing the vessel to sink STBD side first.

- Vessel was subjected to rainfall and winds at the time of event.
- A check valve was installed in the bilge pump discharge line. Check valves are known to stick and block the water from discharging out of the boat (according to the Small Boats Program Inspector).

- Weigh the boat and compare to delivery weight for possible water saturation of hull foam floatation. Change in weight will cause stability issues with boat.
- Flush and clean outboard and make operable. Change all fluids, fog cylinders, flush fuel system, and dry out electrical components.
- Dry out built in floatation foam.

- Dry and test all electrical circuits.
- Purchase and install new battery.
- Identify Vessel Operational Coordinator (VOC) as required by the NOAA SBSPM.
- Create and promulgate a Small Boat Operations Manual (SBOM) specifically for this vessel.
- Provide training and qualified operators IAW the NOAA SBP SBSPM.
- Seal the ingress of water into all spaces that contain flotation foam by welding and subsequent air testing.
- Reroute the drainage of water from the forward deck space directly to the aft bilge well.
- Remove the check valve from the bilge pump discharge and install an anti-siphon tube at the hull discharge fitting.
- Install non-return devices on the motor well drains.
- Provide additional flotation foam or buoyant chambers to comply with the level flotation requirements of 33 CFR 183, Subpart G.
