## Classic Galvanic Corrosion

**What is it?** The photo shows the remains of an aluminum hose barb and the bronze sea strainer on which it was installed, in this case in line with the raw water intake hose on NOAA / NRT6s SeaArk Survey Launch S3003, during fabrication.

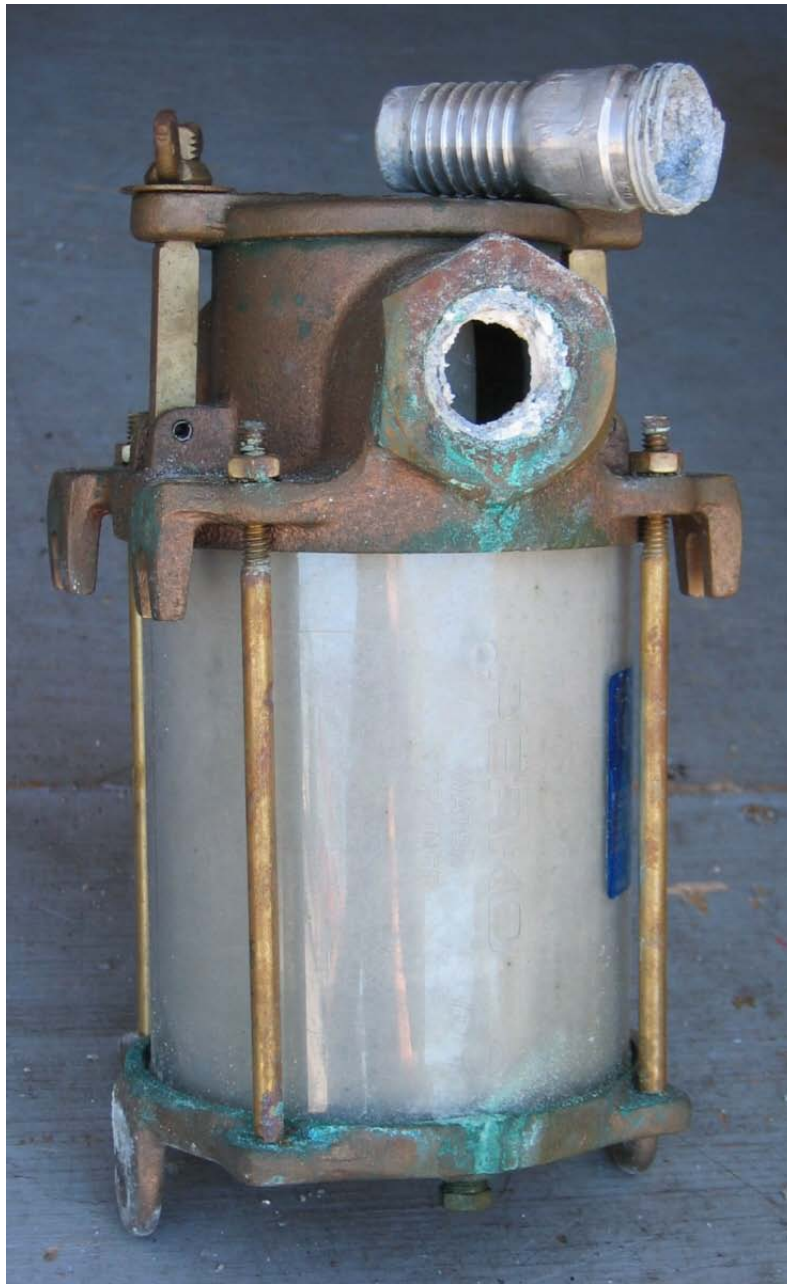
**What's going on?** This is what happens when dissimilar metals are placed in contact with each other, in the presence of an electrolyte, in this case sea water. Aluminum is near the bottom of the galvanic (noble) scale (or near the top, depending on which scale you are using) and therefore becomes the anode, while bronze is closer to the top (or bottom) of the galvanic (noble) scale and becomes the cathode. This is essentially like a battery. In simple terms, the less noble aluminum gives up its electrons to the more noble bronze. In the process the aluminum breaks down (corrodes) to aluminum oxide plus free electrons flowing through the electrolyte (sea water) to the bronze. Another good example of this is when we install sacrificial anodes or "zincs" to prevent an aluminum hull (or other metal parts) from corroding. The zincs (less noble) "sacrifice" themselves by giving up their electrons to the aluminum (more noble).

**How come?** The aluminum hose barb should never have been installed into the bronze sea strainer. The hose barb should have been made of bronze like the sea strainer or at least stainless steel which is closer to bronze on the galvanic (noble) scale. Because aluminum and stainless steel are quite similar in appearance, most likely this was intended to be a stainless steel barb, but somehow an aluminum barb was installed by an inexperienced or "in a hurry" technician, not realizing the difference. This could easily happen because in building aluminum boats one would usually use aluminum barbs on aluminum fixtures, except in the case where it is used in a dissimilar metal fixture like our bronze sea strainer or stainless steel valve, for instance.

**So what?** In our case this went unnoticed for about two to three years after taking delivery of the vessel. The first clue was when we spotted a green (bronze oxide) drip in the bottom of the bilge under the sea strainer. (This would have gone undetected, had there been water in the bilge). I remember pointing it out to my co-worker as something to keep notice of, as a possible sign of future trouble. I thought at the time that the fitting was perhaps just leaking slightly and intended to "get back to it later". Wrong! Unfortunately we got busy and forgot about it as we moved on to other things. Just by luck, a few weeks later, we had the boat on the trailer for maintenance on the generator when I accidentally bumped the hose attached to this barb and it literally fell apart. It had

completely corroded through due to galvanic corrosion. Had this not happened while on the trailer, it would most likely would have happened while under way.

**How to prevent this:** With the boat on its trailer or at least with appropriate valves shut off to prevent flooding, inspect any suspect fittings, like the hose barbs that are attached to any bronze or stainless steel fittings, such as sea strainers, valves etc. Look for leaks and/or signs of corrosion between the parts. Grasp the hose attached to the barb and give it a good shake or tap with a hammer or both. If the corrosion is severe the barb might break, like the one in the photo.

If this does not show results, as in a newer vessel, verify the composition (type of metal) of any suspect fittings. If the fitting is bronze it will be a dull golden/brown color. Aluminum is usually duller than stainless steel and has a more "whitish" appearance, while stainless steel has a more silvery color and shine. Aluminum also has less of a "ring" to it when tapped with a metal object such as a wrench, but this may not work if attached to other fixtures. Aluminum is much softer than stainless steel and will scratch much more readily with a knife or other sharp object. Try to find other fittings for comparison. If you're still not sure, have it checked next time the vessel goes into the shop or ask someone with more experience. If you are about to have a vessel inspection done, that might be a good option. Ultimately, the best option is for the vessel operator to know his/her vessel.

Any fittings of dissimilar metals that are attached to each other should be suspect especially in critical applications, as when in contact with seawater. Have these fittings replaced as soon as possible.
