# Boating Safety Circular 79

## THERE ARE NO "MAINTENANCE-FREE" METALLIC FUEL TANKS

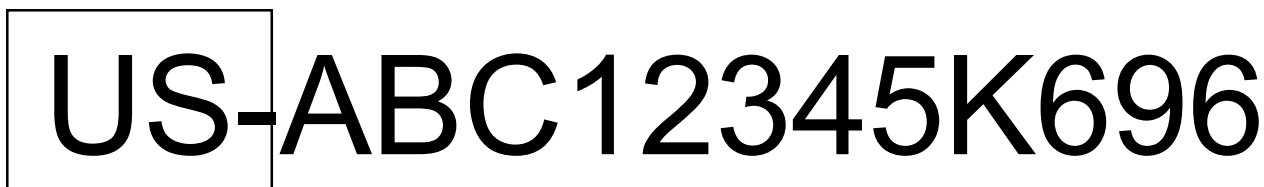
US-ABC12345K696

2. Surround the country code and hyphen to the left of the existing HIN format with a border or display the country code and hyphen on a separate label.
